**NASA John C. Stennis Space Center, MS 39529**

### **Abstract**

## Introduction

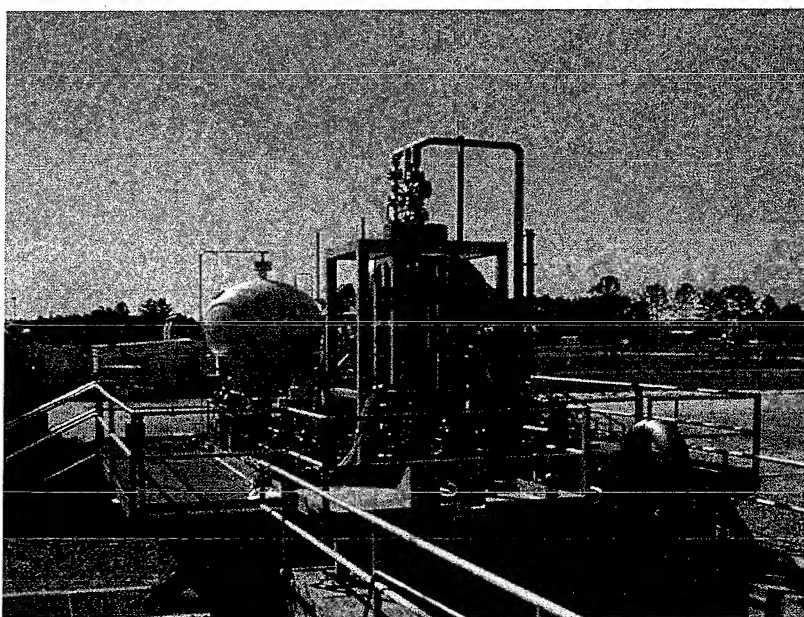
**Figure 1. E3 Cell 2 High-Test Peroxide Test Stand**  
(Test Article & TMS Installed at Vertical Position)

This paper will also provide a brief overview of programs utilizing this facility as well as describe some of the handling and safety issues encountered in development of the facility. The facility and its capabilities are further described in the attached Addendum I. Figure 1 illustrates a nominal test configuration for Cell 2.
